SERVICE BULLETIN					
Classification:	Reference:	Date:			
AT05-009a	NTB05-084a	November 20, 2006

MURANO; LACK OF POWER ON TAKE OFF WITH DTC P0868 STORED IN THE TCM AND NO MIL ON

APPLIED VEHICLES: 2003 - 2007 Murano (Z50)

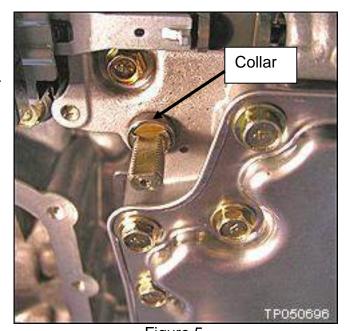
Figure 5

9. Remove the collar from the manual shaft.

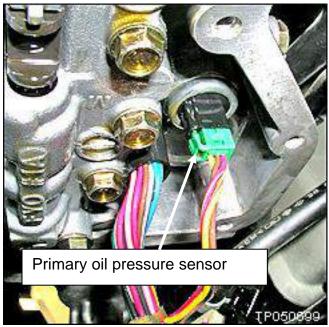
Figure 8

11. Disconnect the harness of the Primary oil pressure sensor.

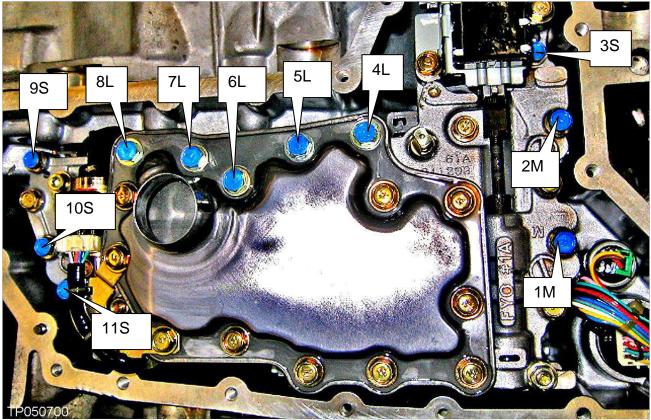
Figure 9

- 12. Remove the bolts attaching the valve body to the transmission (see Figure 9).
 - There are 11 bolts shown and numbered for convenience.
 - There are 3 different length bolts which are identified by:

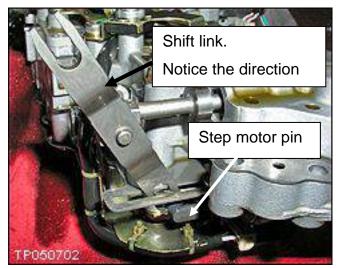
Figure 12

- 15. Carefully unpack the new valve body assembly. When installing the new valve body, be careful not to allow the Ratio Control Valve to fall out (see Figure 10).
 - If the Ratio Control Valve does fall out, check the condition of all surfaces especially the edges for damage.
 - Confirm (double check) the direction of the shift link and the bottom of the shift link around the step motor pin (see Figure 12).

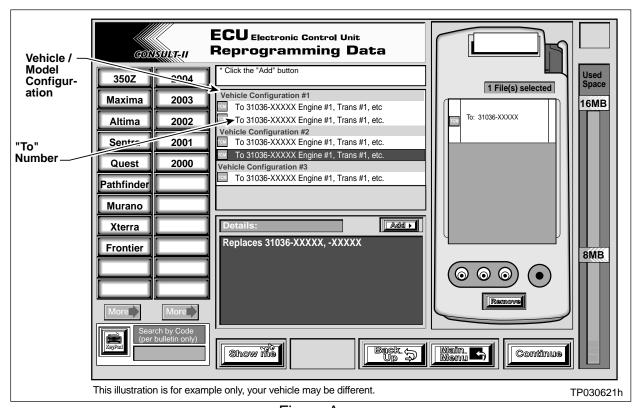
Figure A

- 1. Select vehicle model and model year (example: Murano, 2004).
- 2. Select the correct reprogramming data:
 - a. Locate the specific "Model Configuration" (Example: VQ35, CVT, 2WD).
